FEASIBILITY STUDY

WALDO HALL

Oregon State University
Corvallis, Oregon

Bear, McNeil, Schneider, Bloodworth & Hawes
Architects
5502 N. E. Glisan Street
Portland 13, Oregon

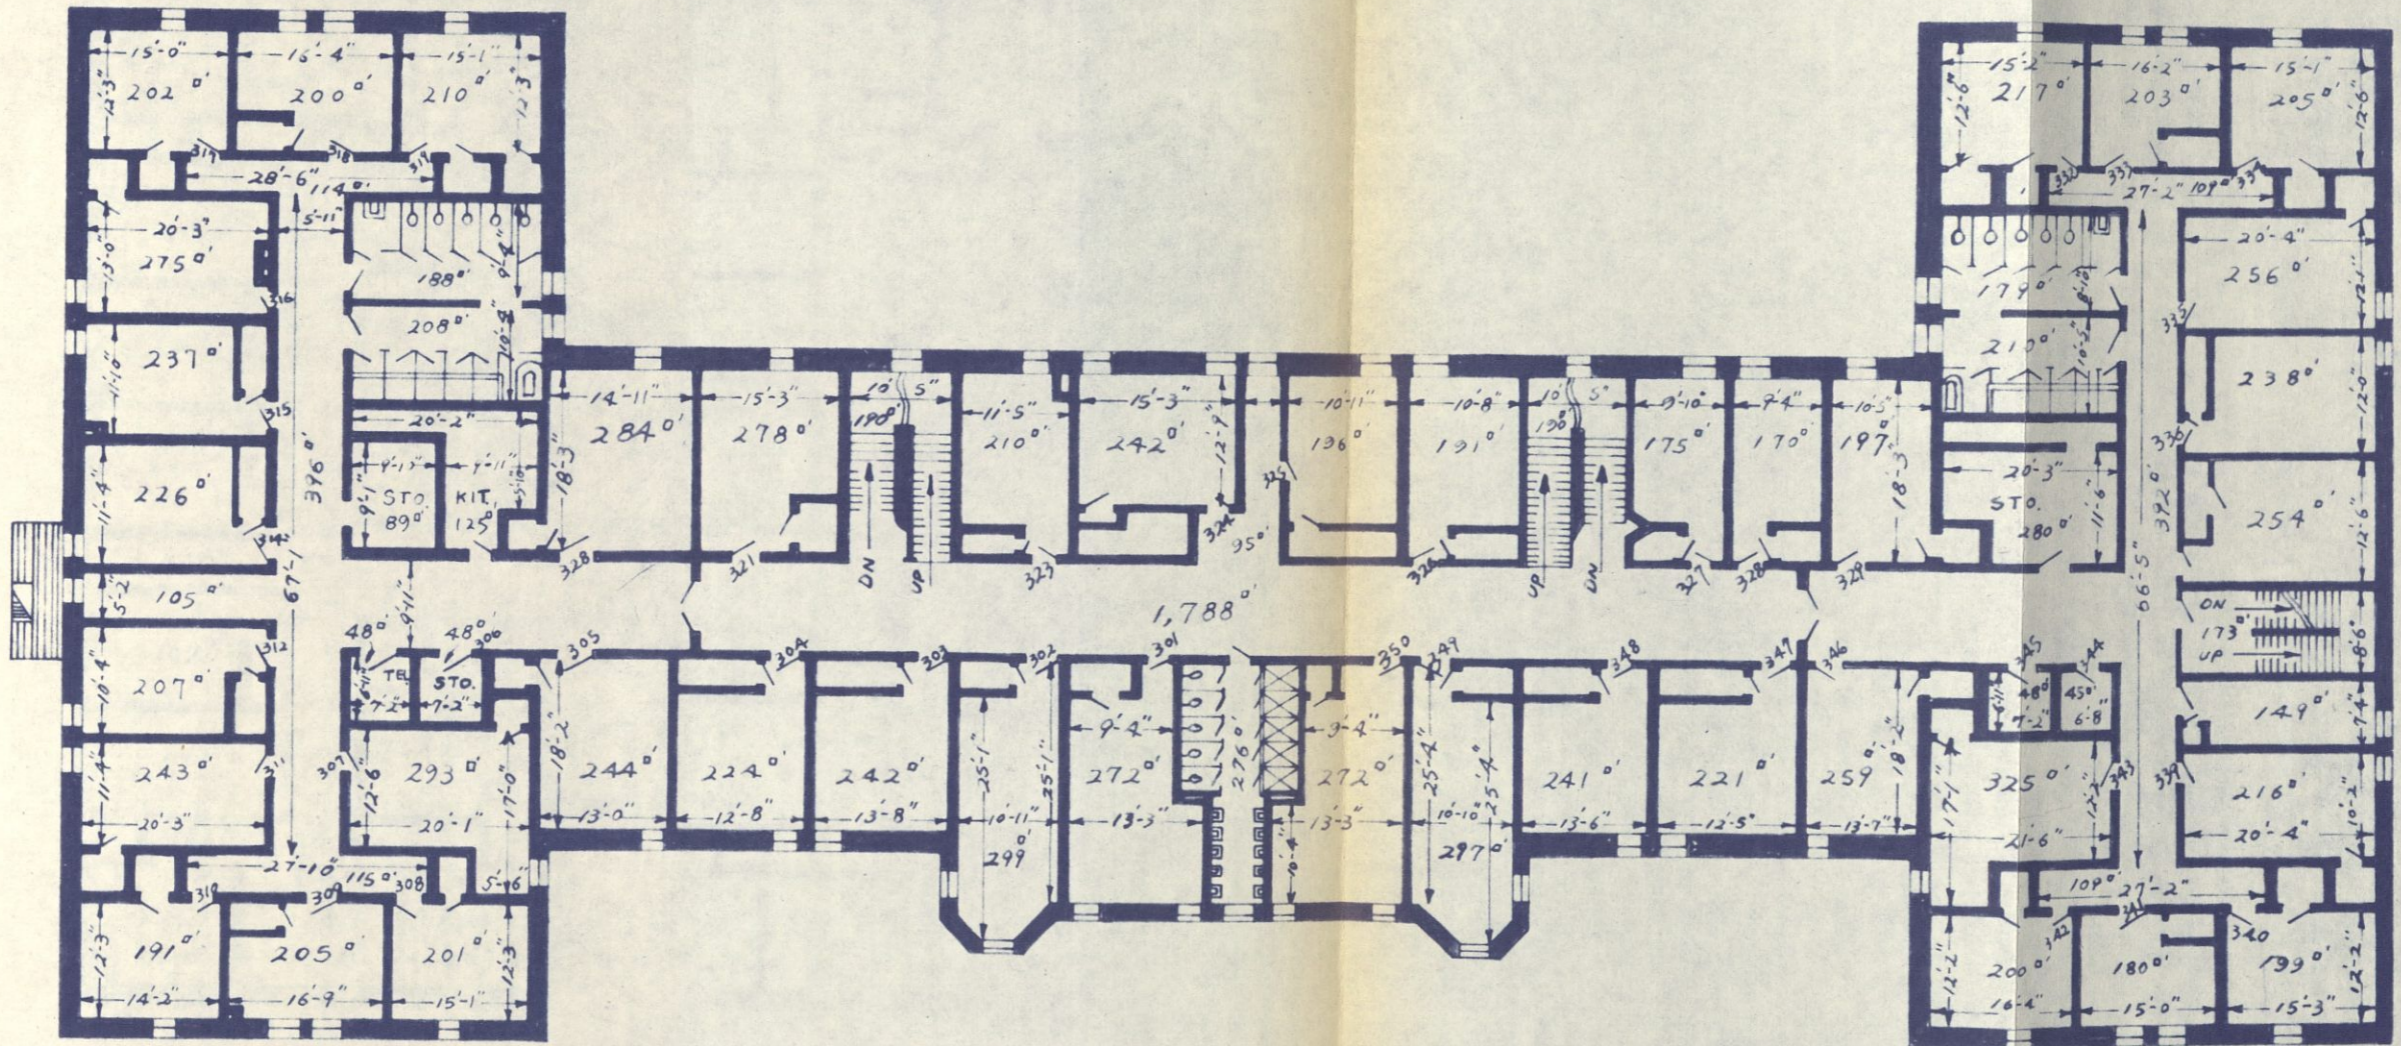
SCALE $\frac{3''}{64} = 1'-0''$
 AUG., 1961
THIRD FLOOR

USABLE SQ. FT. 15,204
 GROSS SQ. FT. 17,401

AREA SUMMARY - GROSS	
FIRST FLOOR	19,351 Sq. Ft.
SECOND FLOOR	19,251 Sq. Ft.
THIRD FLOOR	17,401 Sq. Ft.
FOURTH FLOOR	17,401 Sq. Ft.
TOTAL	73,404 Sq. Ft.

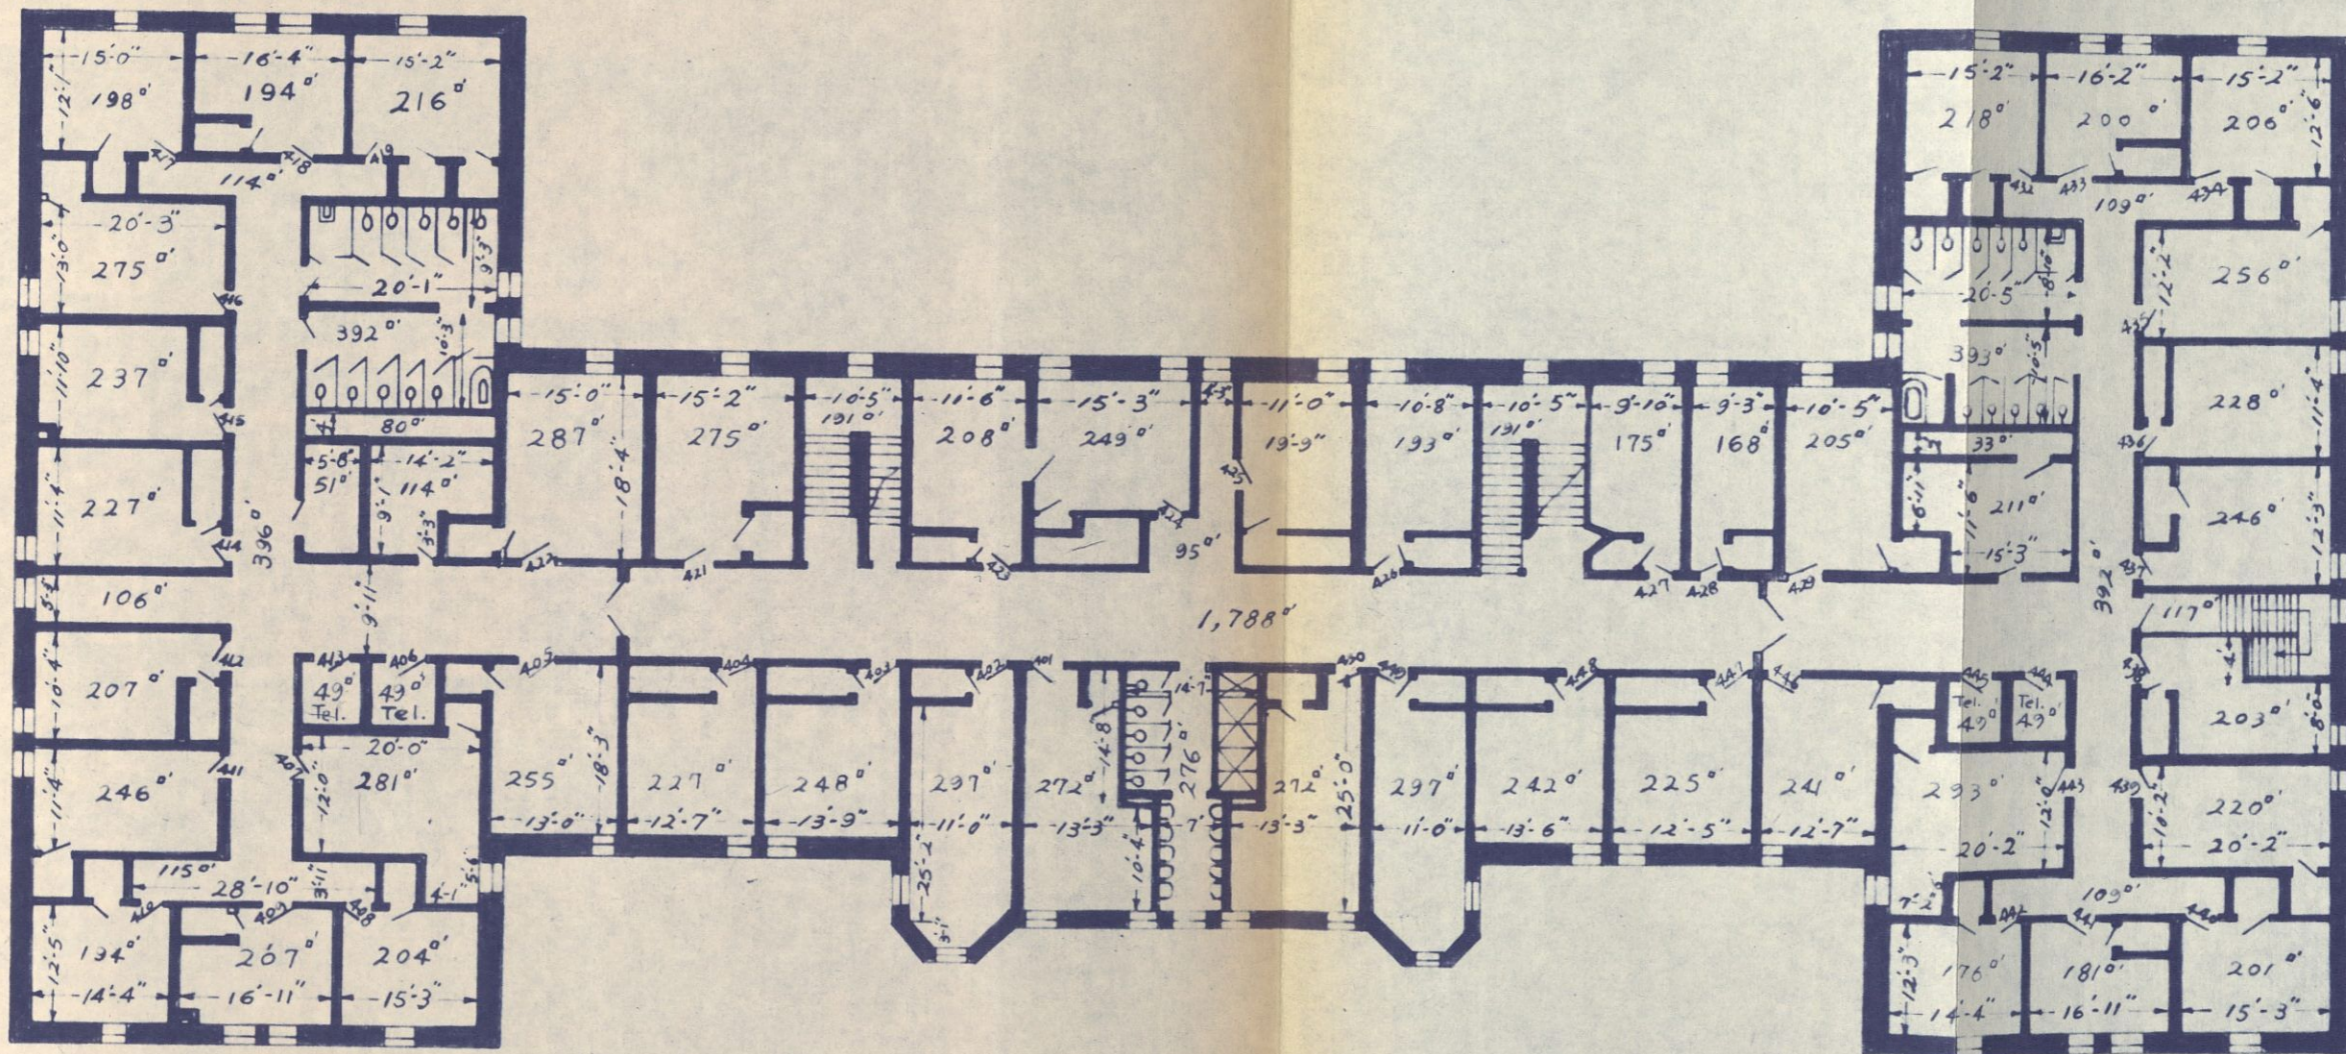
USABLE SQ. FT. 15,203
 GROSS SQ. FT. 17,401
